# NBS SPECIAL PUBLICATION 592

## An Investigation of the Miyagi-ken-oki, Japan, Earthquake of June 12, 1978

On June 12, 1978, a destructive earthquake with Richter magnitude of 7.4 occurred off the east coast of Miyagi Prefecture, Japan. Preliminary estimates by the National Land Agency of Japan indicated that the earthquake caused an equivalent of \$800 million in total damage. There is a cooperative agreement between the governments of the United States and Japan termed the U.S.-Japan Program in Natural Resources (UJNR). Following the earthquake, it was arranged through UJNR that teams of U.S. structural engineers and geologists would visit Miyagi Prefecture and inspect the damage caused by the earthquake. This report assembles the information and collective experiences of the investigation team so as to describe the earthquake and document its effects. Field investigations conducted by geologists and structural engineers are described in detail and some of the implications for seismic resistant design and construction of structures in the United States are also discussed.

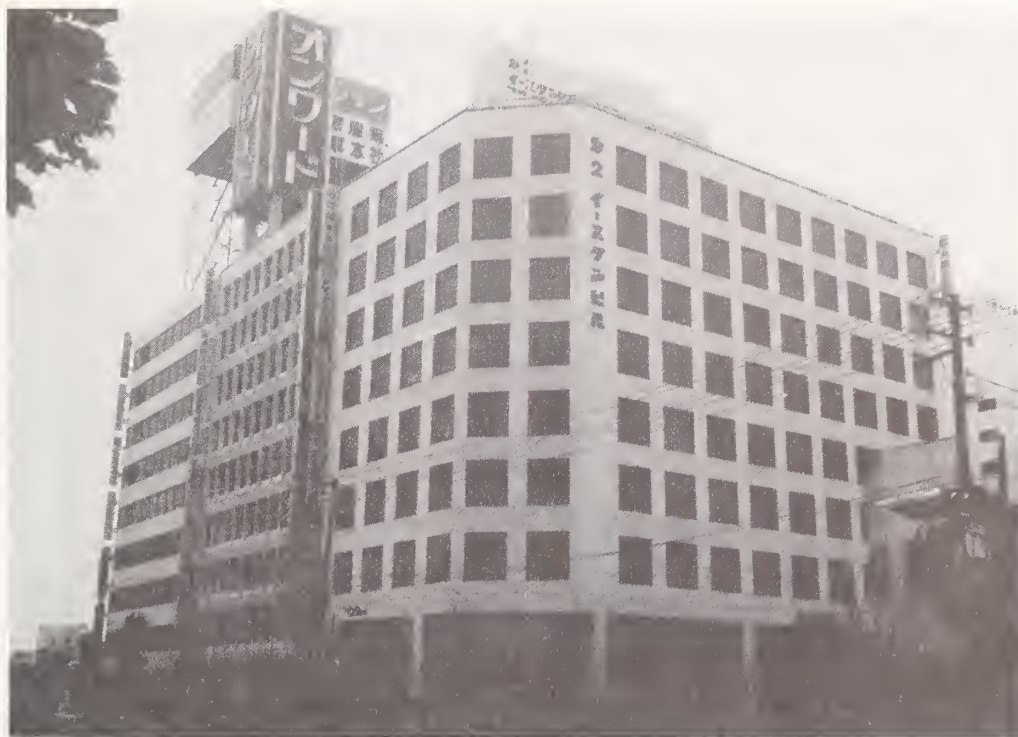
Figure 5.6 Second Eastern Building Company Building, Sendai. A typical modern building in Sendai; the only apparant damage to the glazed tile veneer on the exterior was cracking on spandrels and shear walls.

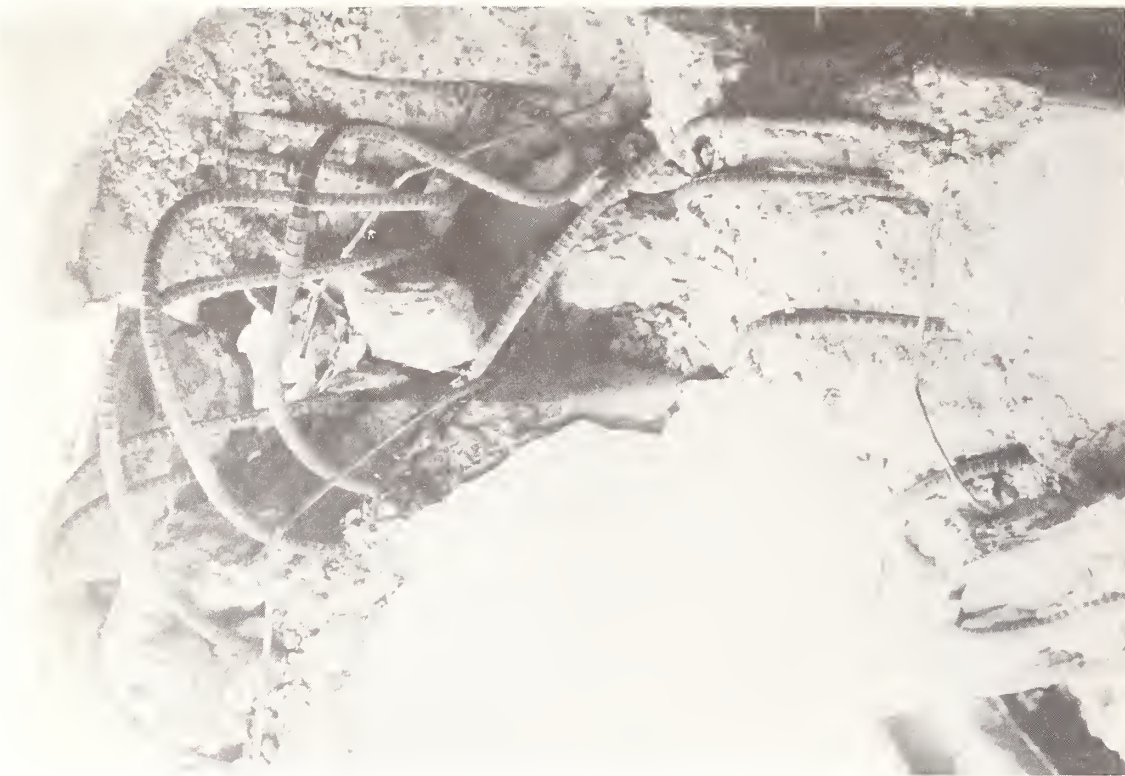
Figure 5.43 Yazaki Industries Buildings. Detail of column shear failure, east side. Note use of deformed bars.

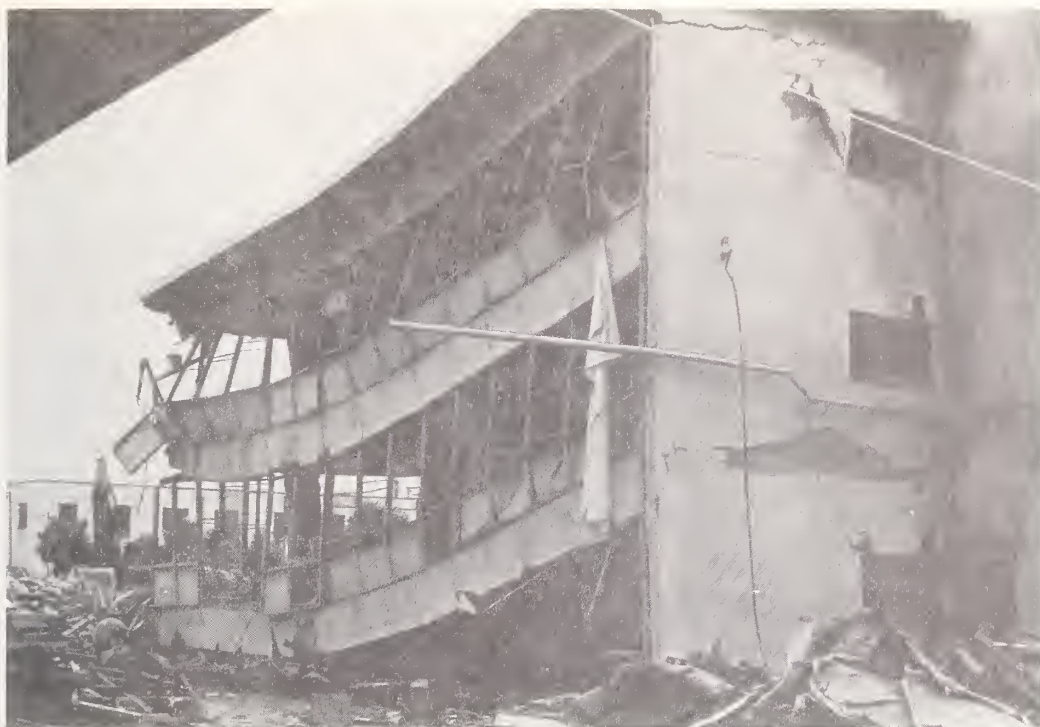
Figure 5.52 Taiyo Fisheries Plant, viewed from the northeast. The reinforced concrete shear wall on the north end was badly damaged.

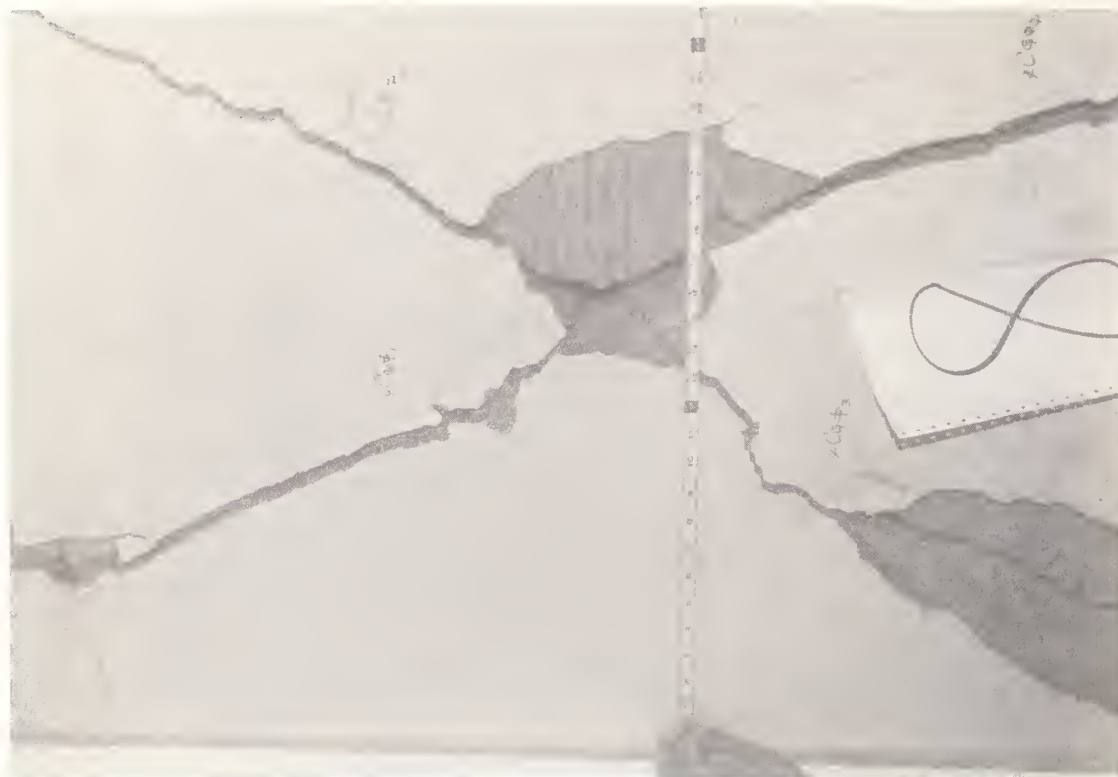
Figure 5.68 Tohoku Institute of Technology,  
Building 5. Detail of column damage.

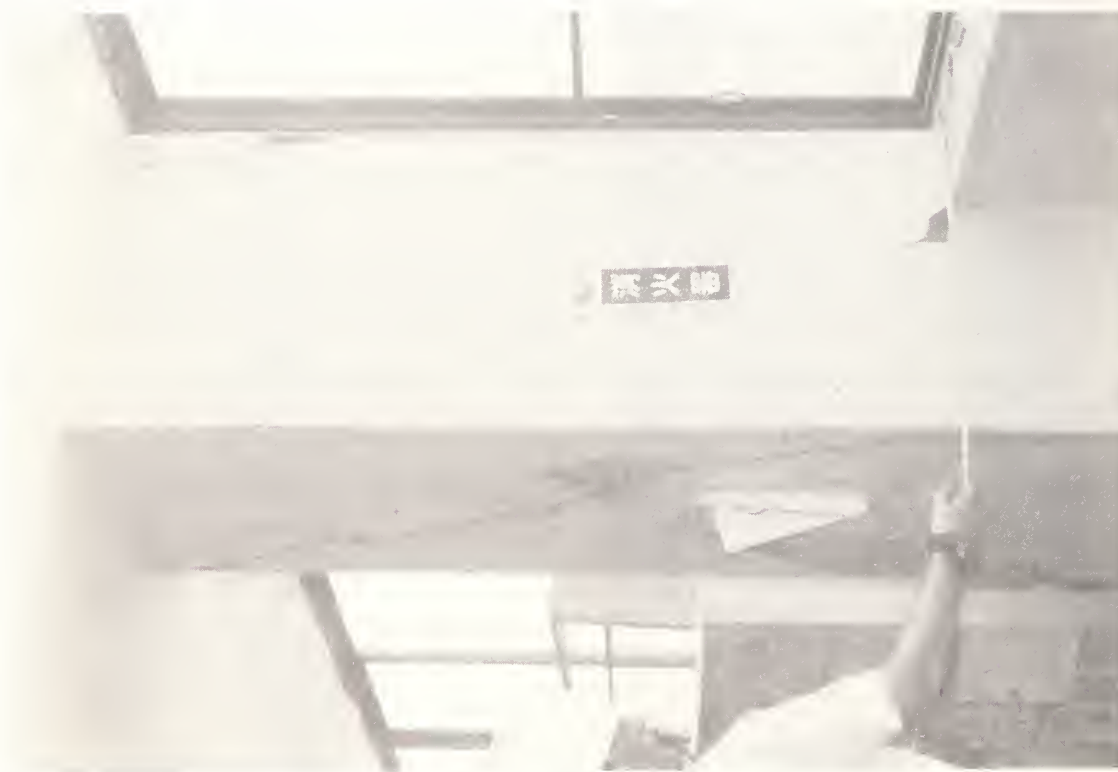
Figure 5.67 Tohoku Institute of Technology. Typical  
damage to seventh story column of the  
north facade of building 5.

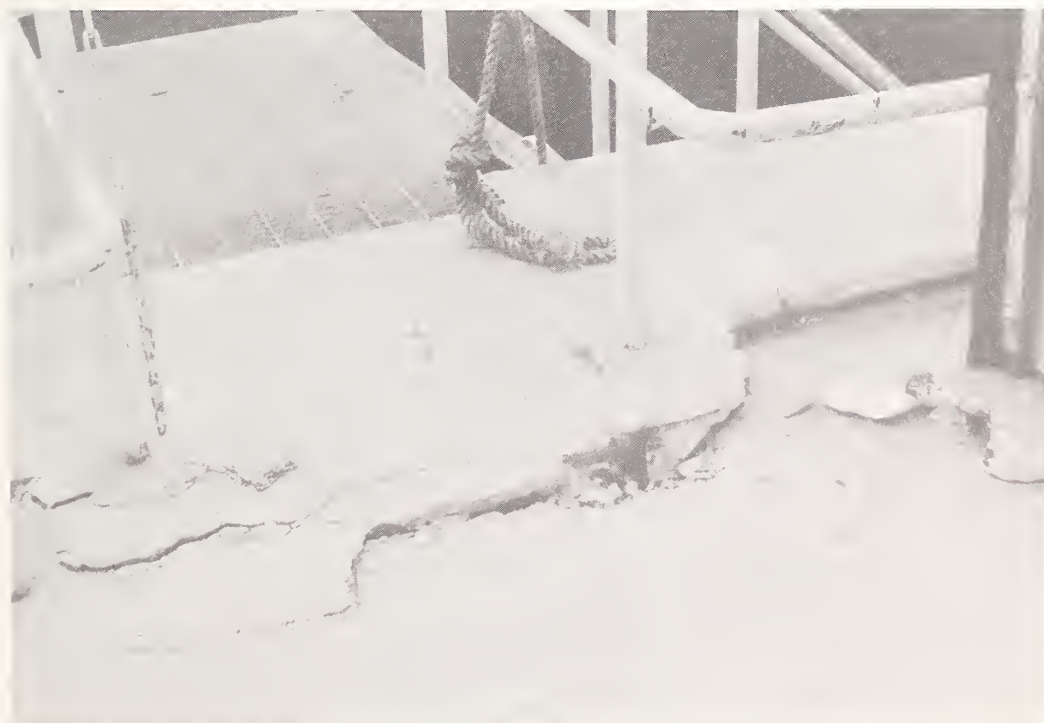
Figure 6.16 New Sendai Power Plant, Tohoku Electric Power Company: a loosened exterior facing panel in the turbine building. This was the only obvious damage to the exterior of the structure. The shear walls of the adjacent administration building showed extensive cracking.
